TECHNICAL BULLETIN

MODEL/DERIVATIVE:
Discovery Series II (LT)

Bulletin N°: **0117**
CDS. ref: **L8861bu**
Issue: **1**
Date: **03.07.03**

WATER INGRESS - WET HEADLINING

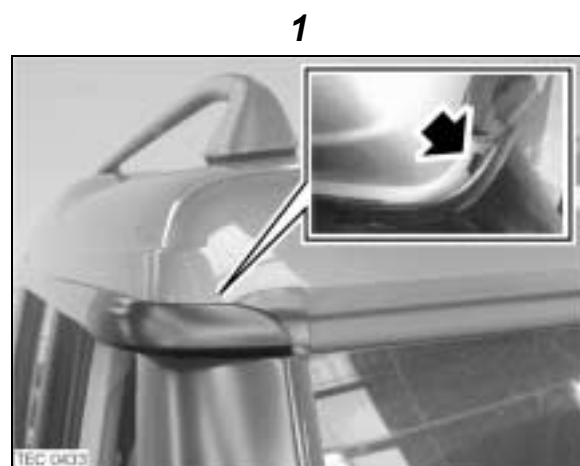
1. Carefully lift the clip securing the drip rail corner finisher to the drip rail (arrowed in illustration 1), and inspect the drip rail seam joint for a gap / void.
2. If a gap / void is present, refer to the drip rail rectification procedure.

1. Remove the windscreen side finisher. Refer to Workshop Manual, part number VDR100090 (8th edition), Exterior Fittings, Side Finisher - Windscreen, repair number 76.43.39.
2. Release and remove the drip rail corner finisher from the drip rail.
3. Clean the drip rail.
4. Fill the gap / void with sealant (see illustration 5).

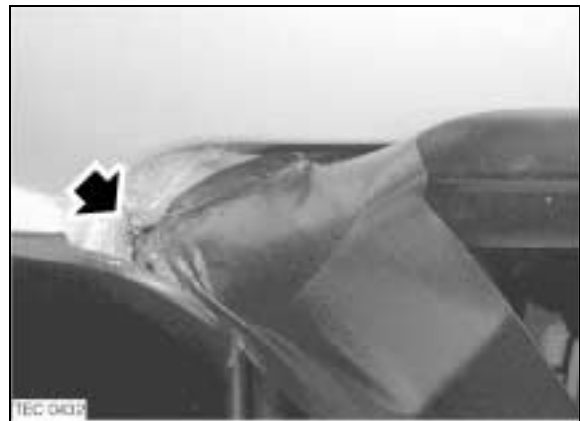
3

3. Carefully pull back the corner of the windscreen upper finisher and using tape secure it to the windscreen (see illustration 2).
4. Inspect for pin-holes / cracks around the 'A' post / roof panel, and the drip rail sealed joints (arrowed in illustration 3).
5. If pin-holes / cracks are found; refer to the 'A' post / roof panel rectification procedure.
6. If no pin-holes / cracks are found; remove tape securing the windscreen upper finisher to the windscreen and push the windscreen upper finisher back into position.

1. Clean the area and fill any pin-holes / cracks with sealant (inset in illustration 4).
